Environmental Effects of Coal Tar-Based Pavement Rejuvenators

A Major Qualifying Project
Submitted to the Faculty of
WORCESTER POLYTECHNIC INSTITUTE
in partial fulfilment of the requirements for the
Degree of Bachelor of Science
in
Civil Engineering

by
Seth M. MacDonald
Caroline D. Meyer

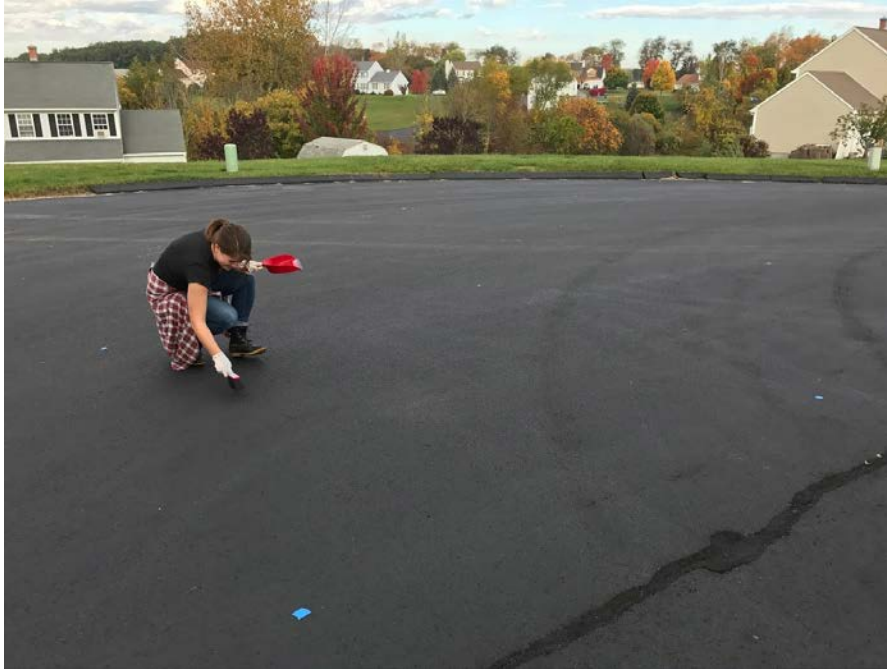
Figure 3: Surface dust sample collection procedure.

Dust samples were collected by sweeping 3 m by 3 m pavement areas at each sampling location with clean hand brooms and dustpans (see Figure 3).

The 9 m² area was marked in each sampling location on the pavement, and all dust was carefully swept into plastic dustpans (see Figure 3).

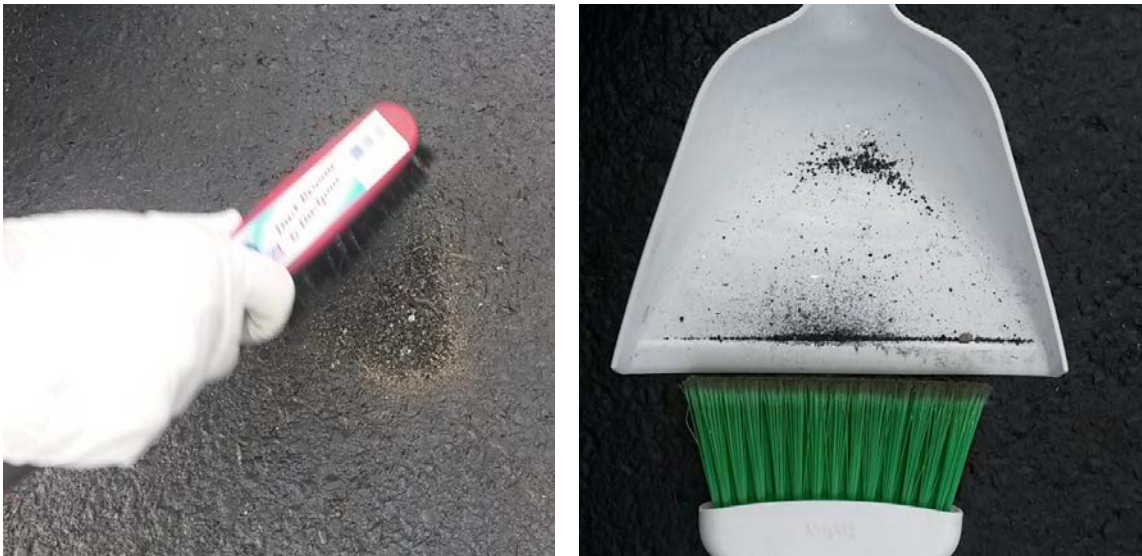
Figure 4: Dust sample collection.

The dustpans and hand brooms shown in Figure 4 were used once for each sample. The

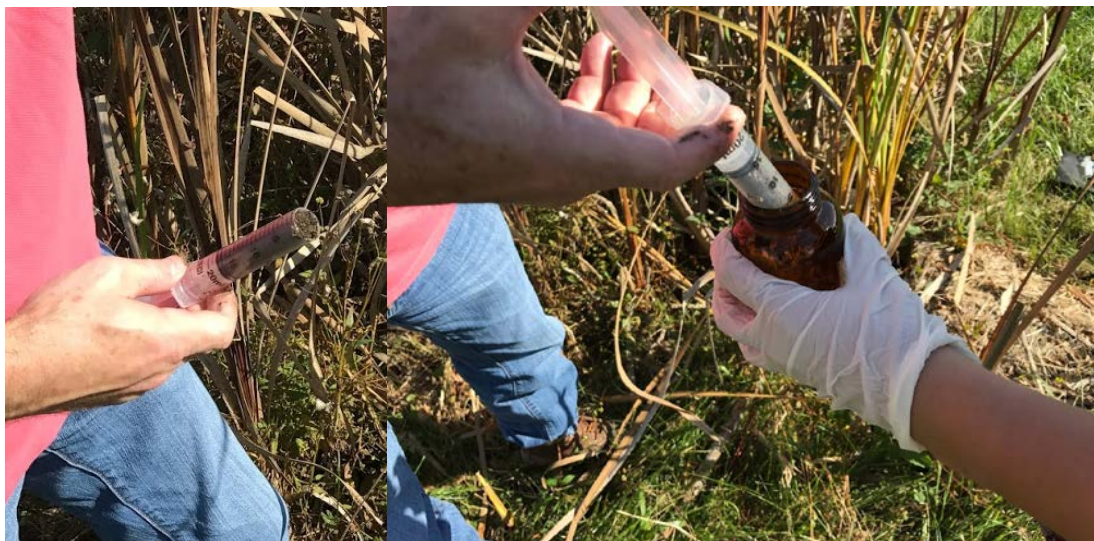
Figure 6: Sediment sample syringe and technique.

Sediment samples were taken in a swale, at a location down gradient of a catch basin outfall where sediment/dust/solids deposition was expected. Samples were collected using a syringe modified by cutting the rounded top and needle off, leaving the front of the syringe fully open (see Figure 6).

The open end of syringe was pushed into the sediment in a perpendicular direction while withdrawing the plunger, effectively filling the syringe with sediment. This syringe was then emptied by depressing the plunger, releasing the sediment into clean glass collection vials that were labeled, itemized and sent with detailed collection logs to the USGS National Water Quality Laboratory for full analysis (results were not received by the date of this final report). Syringes were cleaned between samples by rinsing with methylene chloride and then purified water. Purified water was produced with a Thermo Scientific Barnstead Nanopure Life Science UV/UF system.

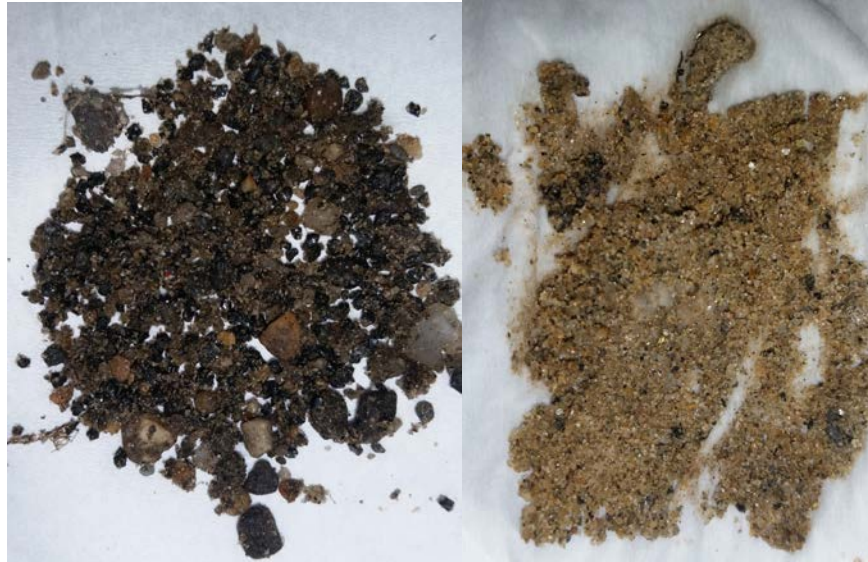
Figure 15: Sample contents in November (left) before sand use vs February (right) after sand use.

Since November, TPAH concentrations in the catch basin sediment have been varied. TPAH concentrations in CB5 were relatively constant while there was a significant decrease in CB3 sample concentrations from November to December, possibly explained by the sudden increased use of sand and salt on the road during inclement weather in the winter. The subdivision pavement was treated with a sand and salt mix during snow storms and freezing weather; total sand use in the Longmeadow Drive subdivision in the winter season totaled “not more than 5 tons of 2:1 sand:salt mixture” (Baldwin, 2017). The application of sand would be expected to dilute the TPAH concentrations in the samples: more inorganic (sand) material was being washed into the catch basins, causing a decrease in TPAH concentration (yet still above the reference site concentrations). Figure 15 clearly shows this dilution as displayed by the high concentration of black particles seen in November samples when compared to the low concentration found in February samples. Figure 16 displays the high amounts of sand present at the study site in the month of January and Figure 17 showing the excess sand remaining at the study site in April.

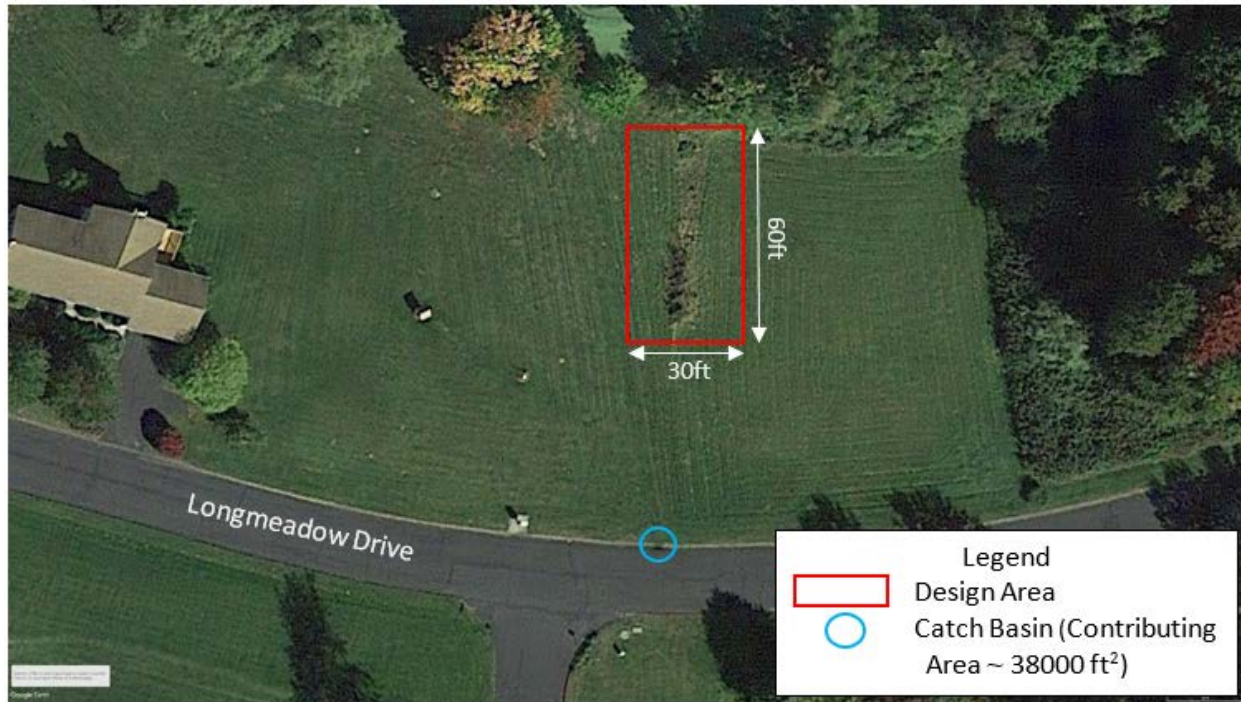
Figure 20: Bioretention area design location plan.

The US EPA recommends a bioretention facility that is at least 4% of the impervious area that contributes to the offsite flow in a given catchment area ($\text{Impervious area} \times 0.04 = \text{Design area}$). Using CB 5 on Longmeadow Drive, which has a catchment area of around 38,000 sq.ft. of impervious surface, a bioretention facility at 1,520 sq. ft. would be sufficient in treating the outflow for water quality purposes. Figure 20 portrays a potential location for this design area (60 ft x 30 ft) in order to remediate potential PAH outflow from CB 5 into the nearby Medbury pond.
